**Flood Control Project Maintenance  
Levee Inspections**

**Maintenance Issue Types Only, Levee Inspection Report By Mile - Fall 2018**

**Sutter Maintenance Yard Maintenance Area 0003**

Waterway	Bank	Unit Miles	Inspection Start/End	Inspector
Unit No. 01 Feather River	Right	5.11	09/18/2018 09/18/2018	Sterling York

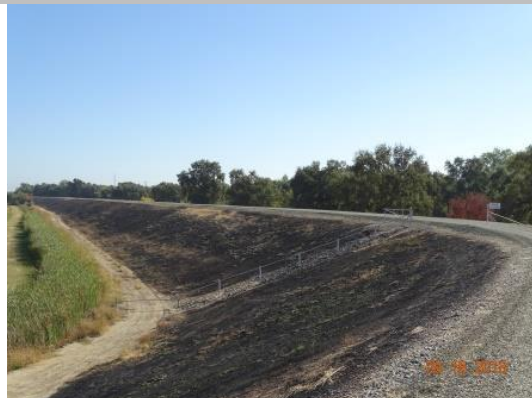
Photo 1 of 1 : FA\_2018\_MA0003\_195\_8\_20181003\_00020.jpg

LM Start	0.00	Rating **	A	Issue No.	8
LM End	5.10	Issue Type +	Ma	Location *	LS
Category	Earthen Levee			GPS Latitude/Longitude	
				Start	End
Item	Vegetation			38.898123°	38.950796°
				-121.617970°	-121.585792°
DWR ID	DWR_MA0003_01_f_2018_8				
Comment Code					
V1 : Control annual grass and weeds on the levee slopes and easements.					
Inspector Comment					
Annual vegetation is well maintained, Fall 2018.

View looking upstream landside of the well maintained vegetation, Fall 2018.

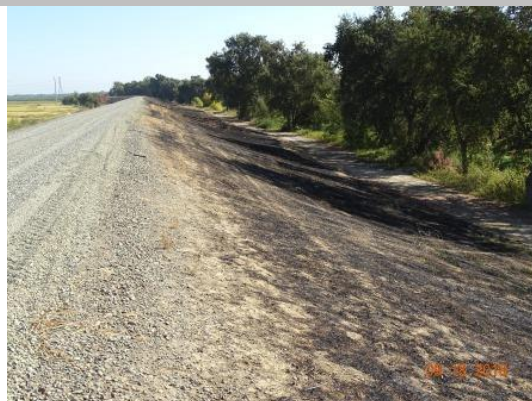
Photo 1 of 1 : FA\_2018\_MA0003\_195\_9\_20181003\_00019.jpg

LM Start	0.00	Rating **	A	Issue No.	9
LM End	5.10	Issue Type +	Ma	Location *	WS
Category	Earthen Levee			GPS Latitude/Longitude	
				Start	End
Item	Vegetation			38.898123 °	38.950796 °
				-121.617970 °	-121.585792 °
DWR ID	DWR_MA0003_01_f_2018_9				
Comment Code					
V1 : Control annual grass and weeds on the levee slopes and easements.					
Inspector Comment					
Annual vegetation is well maintained, Fall 2018.

View looking upstream waterside of the well maintained vegetation, Fall 2018.

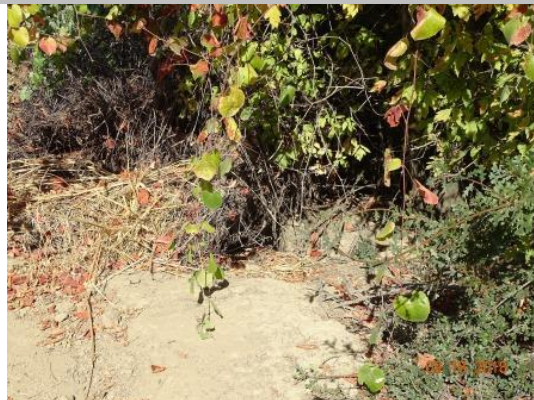
Photo 1 of 1 : FA\_2018\_MA0003\_195\_17\_20181003\_00021.jpg

LM Start	0.69	Rating **	M	Issue No.	17
LM End	0.69	Issue Type +	Ma	Location *	LS
Category	Earthen Levee			GPS Latitude/Longitude	
				Start	End
Item	Animal Control			38.903352°	38.903352°
				-121.607829°	-121.607829°
DWR ID	DWR_MA0003_01_s_2017_17				
Comment Code					
A1 : Exterminate rodents and backfill and compact or grout burrows.					
Inspector Comment					
A large hole on the lanside that look to be from a large animal needs to be repaired, Fall 2018.

The existing animal hole that is on the outside edge of the landside patrol road does not appear to have any recent animal activity and is on the outside of the patrol road not effecting the levee prism, it should be backfilled and monitored, Fall 2018.

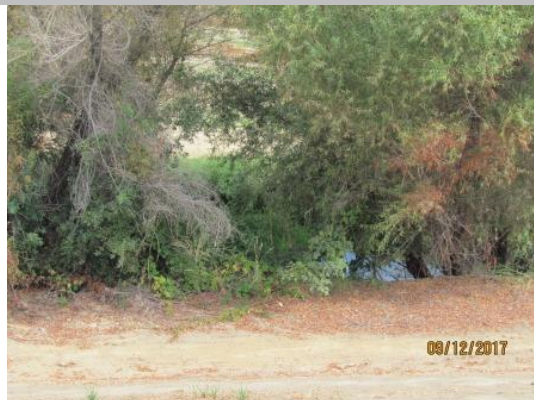
Photo 1 of 2 : FA\_2018\_MA0003\_195\_140\_20180918\_00005.jpg

LM Start	0.78	Rating **	A/W	Issue No.	140
LM End	0.78	Issue Type +	Ma	Location *	LS
Category	Earthen Levee			GPS Latitude/Longitude	
				Start	End
Item	Animal Control			38.903339°	38.903339°
				-121.606209°	-121.606209°
DWR ID	DWR_MA0003_01_f_2014_140				
Comment Code					
A3 : No rodents visible, but rodent burrows visible; need to backfill and compact or grout burrows.					
Inspector Comment					
The rodent hole on the landward toe road was approximately 8" in diameter the hole is no longer there but should be monitored. Fall 2018.

View of where the rodent hole has been repaired, Fall 2017.

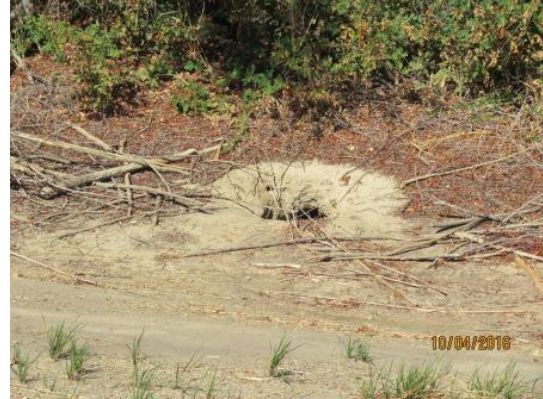
Photo 2 of 2 : FA\_2018\_MA0003\_195\_140\_20180918\_00006.jpg

LM Start	0.78	Rating **	A/W	Issue No.	140 (cont)
LM End	0.78	Issue Type +	Ma	Location *	LS
Category	Earthen Levee			GPS Latitude/Longitude	
				Start	End
Item	Animal Control			38.903339 °	38.903339 °
				-121.606209 °	-121.606209 °
DWR ID	DWR_MA0003_01_f _ 2014_140				
Comment Code					
A3 : No rodents visible, but rodent burrows visible; need to backfill and compact or grout burrows.					
Inspector Comment					
The rodent hole on the landward toe road was approximately 8" in diameter the hole is no longer there but should be monitored. Fall 2018.

This photo was taken from the landward levee slope near the toe road facing north looking at an approximately 8" rodent hole. Fall 2016.

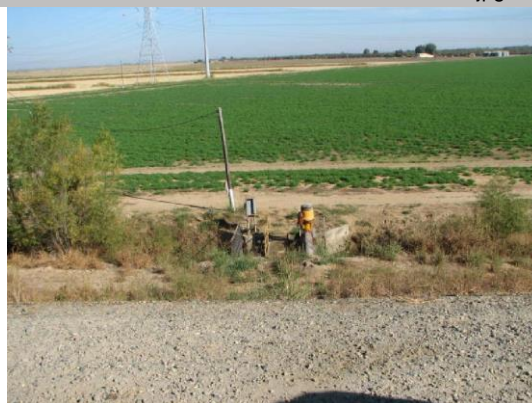
Photo 1 of 3 : UCIP\_FA\_2018\_53409\_64649.jpg

UCIP Comments: 10/04/2018 Sink hole observed between the dual 18-inch pipes located on the LS near the concrete headwall. Erosion was also observed behind the concrete headwall located on the LS. Inlet of dual 18-inch pipes was still covered by filled sandbags. Crossing remains Urgent due to the sink hole and erosion visible on the LS. These crossings were recommended for replacement under the SBFCA project; however, no work has been done to date. Recommend monitoring site and coordinating with SBFCA to determine the status of the project. (O. Magana - DWR UCIP)

Concrete headwall with walkway and slide gates at LS toe.

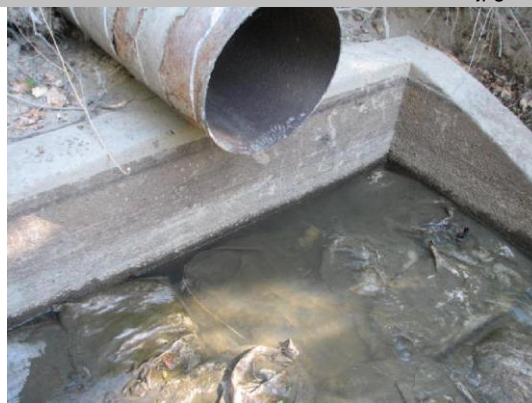
Photo 3 of 3 : UCIP\_FA\_2018\_53409\_64647.jpg

UCIP Comments: 10/04/2018 Sink hole observed between the dual 18-inch pipes located on the LS near the concrete headwall. Erosion was also observed behind the concrete headwall located on the LS. Inlet of dual 18-inch pipes was still covered by filled sandbags. Crossing remains Urgent due to the sink hole and erosion visible on the LS. These crossings were recommended for replacement under the SBFCA project; however, no work has been done to date. Recommend monitoring site and coordinating with SBFCA to determine the status of the project. (O. Magana - DWR UCIP)

Concrete U shaped headwall filled in with sandbags on WS toe. Flap gates appear to be missing and water readily flows through the sandbags from LS.

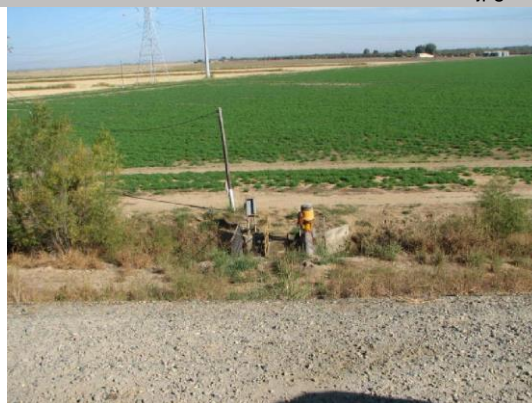
Photo 1 of 3 : UCIP\_FA\_2018\_53414\_64662.jpg

FS\_ID:53414  
DS\_ID:17136  
EP\_NO: N/A  
Repair Type: Urgent  
Crossing Status: Found  
UCIP Comments: 10/04/2018 Sink hole observed between the dual 18-inch pipes located on the LS near the concrete headwall. Erosion was also observed behind the concrete headwall located on the LS. Inlet of dual 18-inch pipes was still covered by filled sandbags. Crossing remains Urgent due to the sink hole and erosion visible on the LS. These crossings were recommended for replacement under the SBFCA project; however, no work has been done to date. Recommend monitoring site and coordinating with SBFCA to determine the status of the project. (O. Magana - DWR UCIP)  
4/11/2017 Water levels were high on WS during inspection so pipe ends could not be inspected. Believe that the sandbags are still in place and condition of flap gates is unknown. (DWR Sutter Yard - afreitag)10/10/2016 WS pipe end was underwater for the inspection but the sandbags appear to still be in place. (DWR Sutter Yard - afreitag)4/18/2016 No repairs have been made to the pipe yet. (DWR Sutter Yard - afreitag)5/12/2015 Watelevel high in WS ditch so could not see WS end of crossing. Do not believe that repairs have been made yet. (DWR Sutter Yard - afreitag)11/17/2014 Same as last inspection. (DWR Sutter Yard - afreitag)5/14/2014 Same as last inspection. (DWR Sutter Yard - afreitag)10/30/2013 Same as last inspection. (DWR Sutter Yard - afreitag)5/21/2013 SBFCA project recommends replacing in accordance with title 23. High water levels in WS ditch have pipe ends underwater but repairs have not yet been completed but are planned for when water levels drop. (DWR Sutter Yard - afreitag)10/10/2012 Flap gates not visible on waterward headwall and it appears as though they have been replaced by sandbags. Slide gates on LS appear to be closed yet water leaks excessively from the WS at the sandbagged headwall. (DWR UCIP - W. Wylie)

Concrete headwall, slidegates, and metal walkway on LS toe.

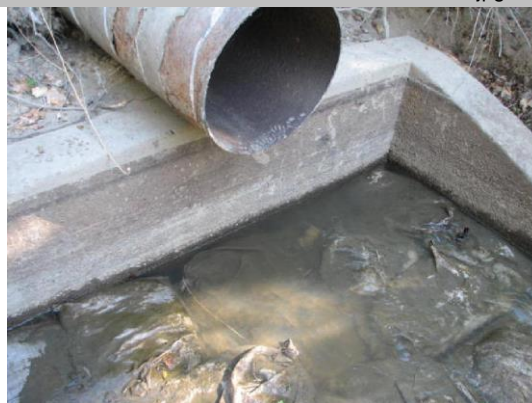
Photo 3 of 3 : UCIP\_FA\_2018\_53414\_64660.jpg

UCIP Comments: 10/04/2018 Sink hole observed between the dual 18-inch pipes located on the LS near the concrete headwall. Erosion was also observed behind the concrete headwall located on the LS. Inlet of dual 18-inch pipes was still covered by filled sandbags. Crossing remains Urgent due to the sink hole and erosion visible on the LS. These crossings were recommended for replacement under the SBFCA project; however, no work has been done to date. Recommend monitoring site and coordinating with SBFCA to determine the status of the project. (O. Magana - DWR UCIP)

Flap gates appear to be missing from U shaped headwall. Sandbags fill headwall but water flows heavily from LS.

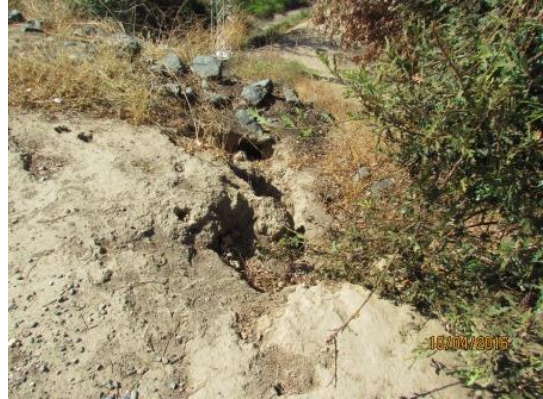
Photo 1 of 1 : FA\_2018\_MA0003\_195\_18\_20180918\_00004.jpg

LM Start	2.18	Rating **	A/W	Issue No.	18
LM End	2.18	Issue Type +	Ma	Location *	LS
Category	Earthen Levee			GPS Latitude/Longitude	
				Start	End
Item	Animal Control			38.911869 °	38.911869 °
				-121.586093 °	-121.586093 °
DWR ID	DWR_MA0003_01_s_2015_18				
Comment Code					
A3 : No rodents visible, but rodent burrows visible; need to backfill and compact or grout burrows.					
Inspector Comment					
No animal activity viewed at time of inspection, Fall 2018.

View of rodent holes that need to be backfilled, No evidence of rodents during inspection. Fall 2016.
